Connectivity Report for Rosemont Copper World Project

December 2021

Rosemont Copper Company

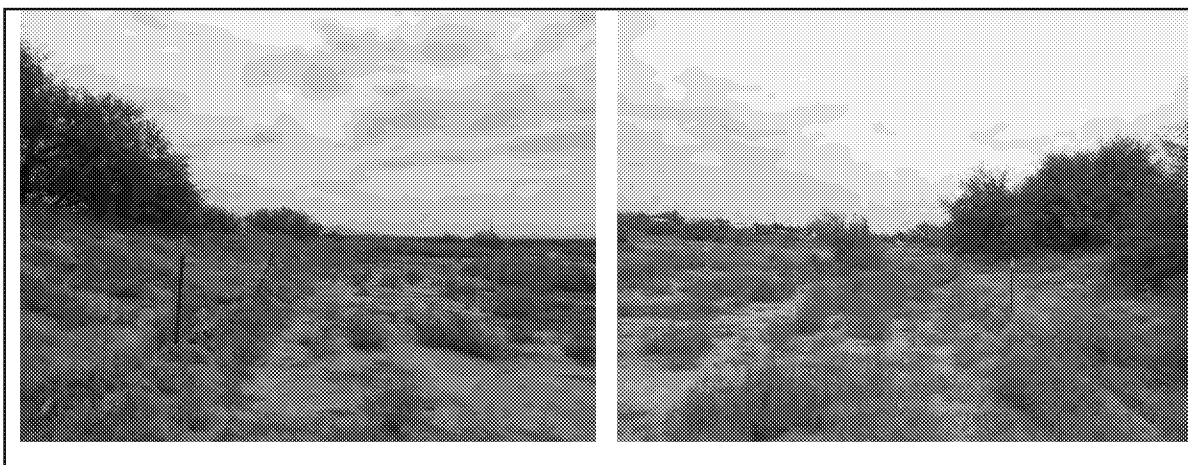
Figure 5. Berms lining property (Sanrita West property) to create flow path shown in center of Figure 4 above.

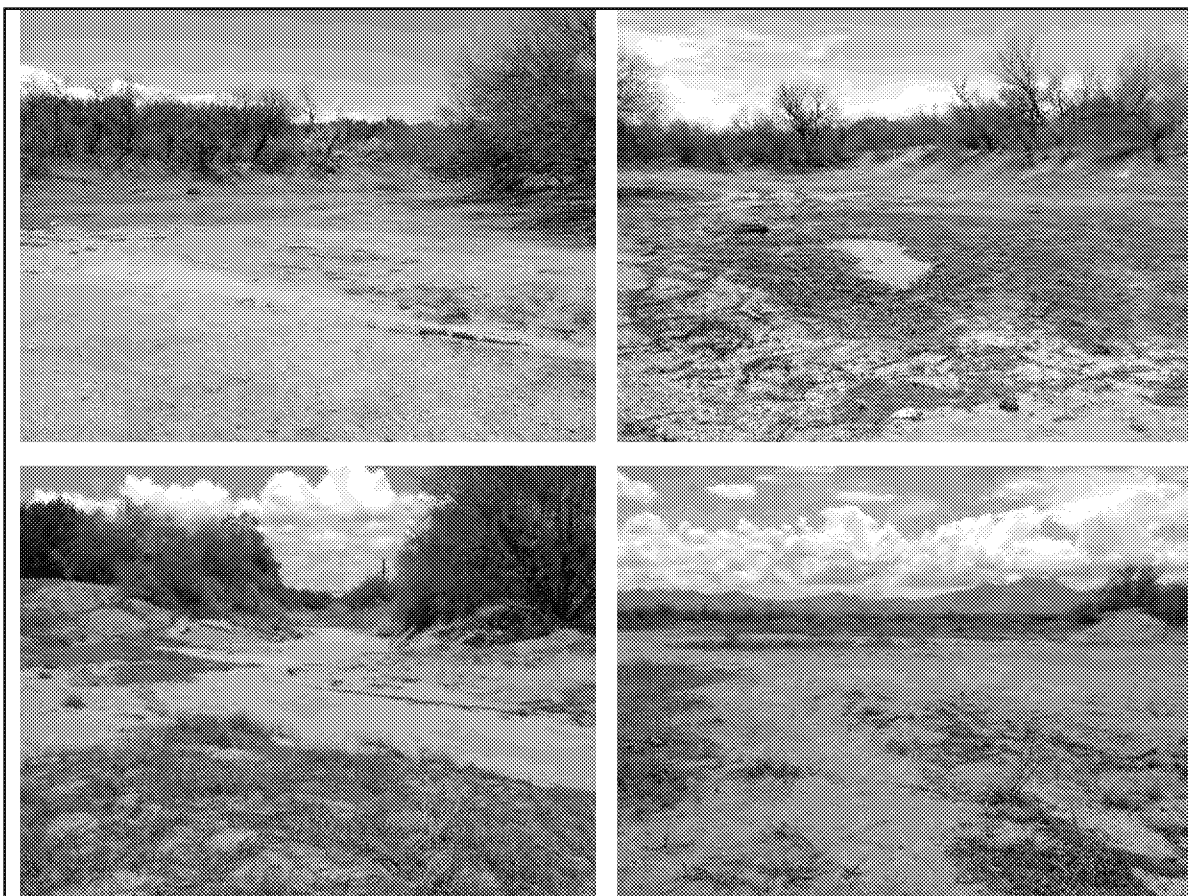
Figure 6. Typical berms observed lining the eastern edge of the pecan orchards, catching or diverting water away from the orchard.

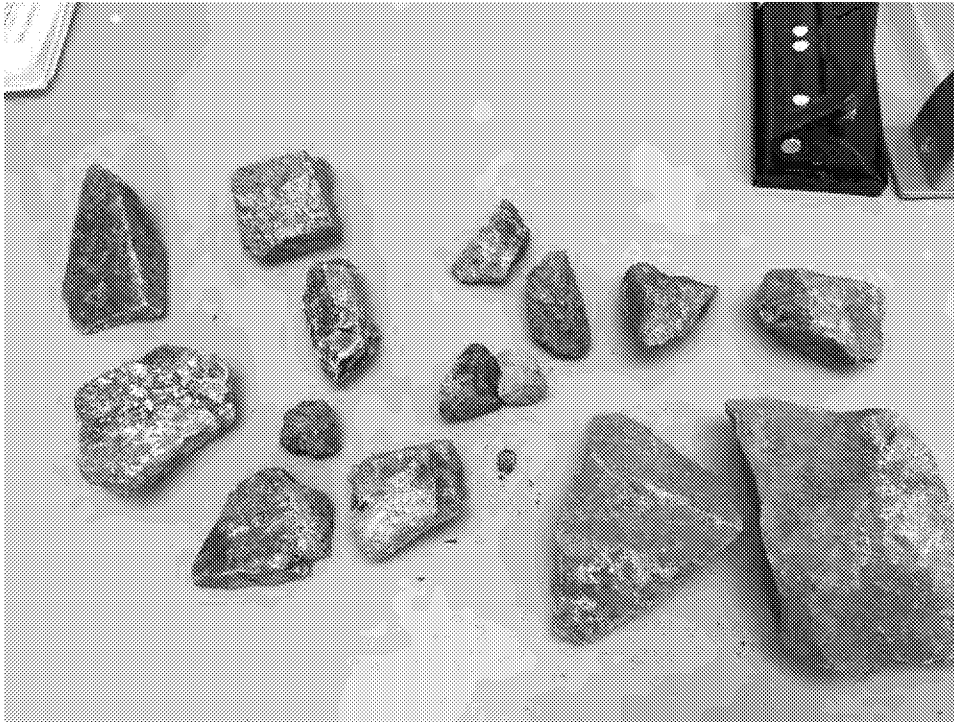
Figure 2: Rocks from culvert fill. Conspicuous green copper oxides and dark brown limonite present.

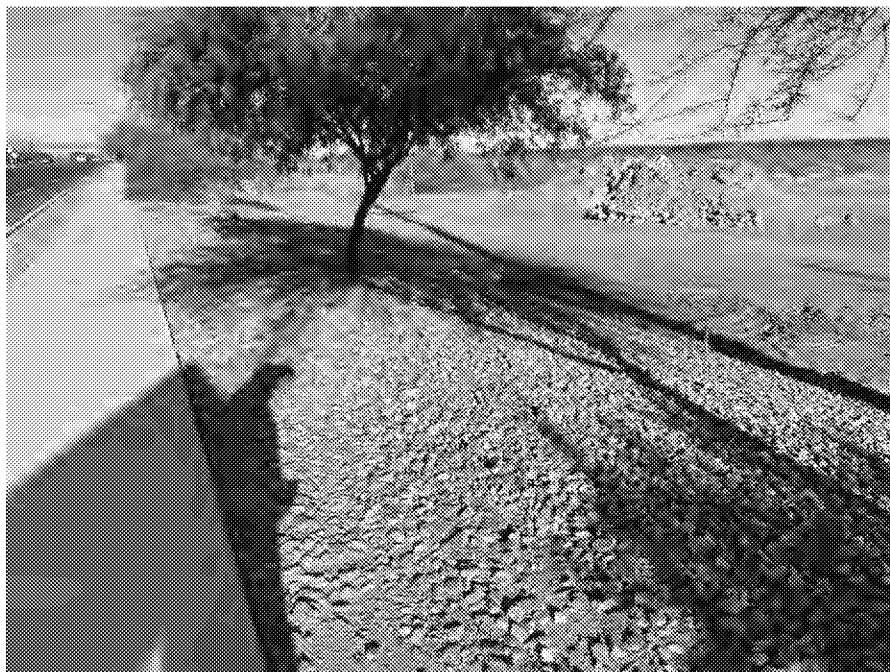
Figure 3: Similar rocks are found over 500' length on either side of the sidewalk on both sides of the culvert. Photo is looking west, taken about 100' east of the culvert.

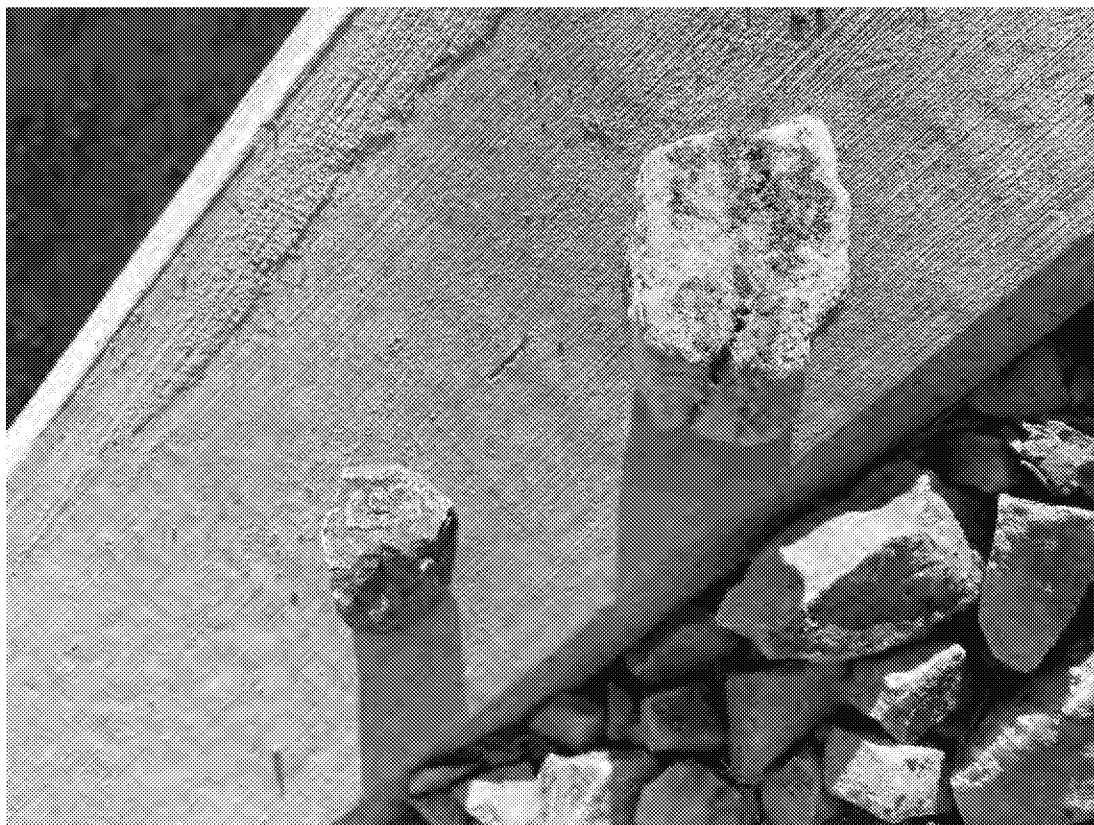
Figure 4: Close up of rocks at culvert. Dark brown limonite on the rock on the right interpreted to be oxidized sulphides.

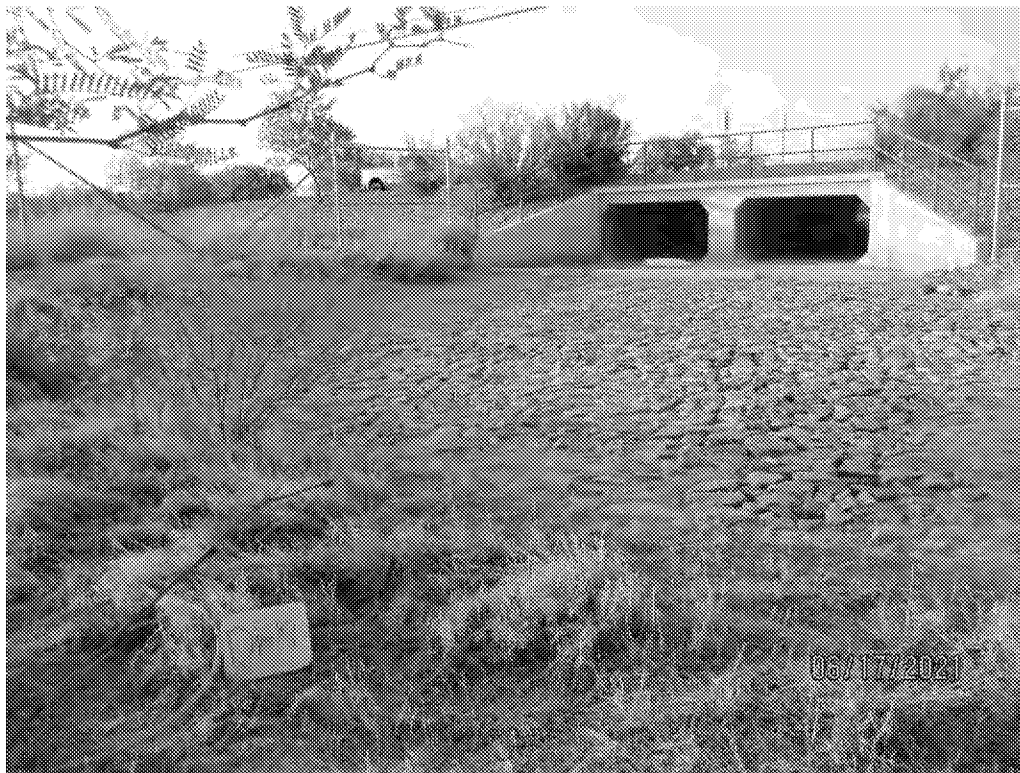
Figure 6: Photo of site on the sampling date looking upstream. Note the rock material both above and downstream the culvert.
